Maintenance of Active Travel Routes in Ceredigion – Overview Report

1. Introduction / Background

2. Current Scenario / Issues

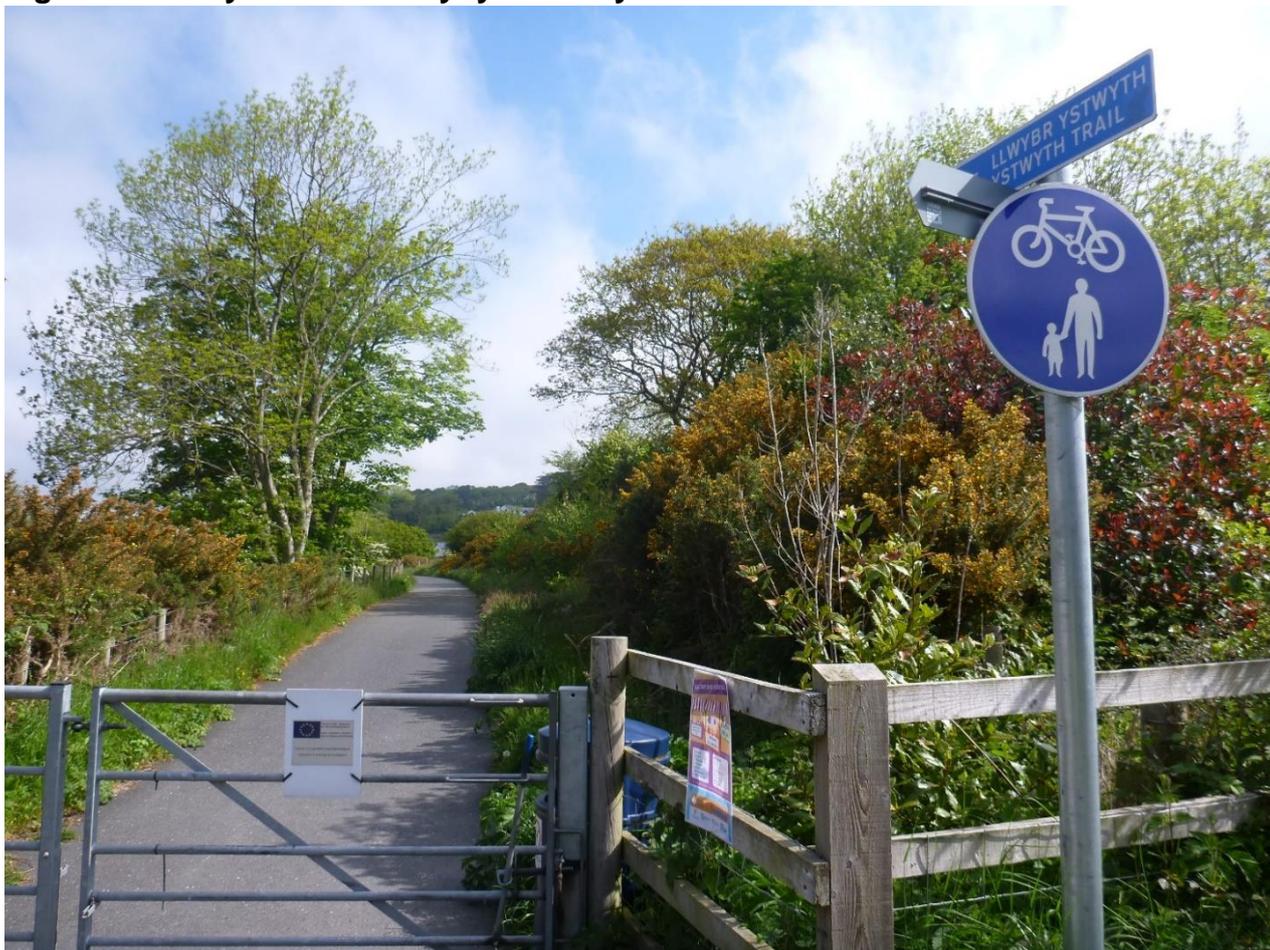
Figure 1: Ystwyth Trail at Rhydyfelin May 2013:

- Figures 1 – 4:** Show the Ystwyth Trail (Ceredigion's 'flagship' cycle route) where vegetation has grown over the years to the extent that the route now appears enclosed and uninviting for users.

- Dedicated Maintenance resource to maintain Primary Active Routes on a more regular cyclical basis and Secondary Routes on a less frequent cyclical basis. There is potential for this work to remain 'in-house' or be allocated to an external contractor.
- CCC Parks and Gardens have potential flexibility to undertake additional maintenance work during winter months, subject to increased resource.
- Maintaining cycle infrastructure i.e. Cycle Shelters (includes annual washing / cleaning) and Bike Repair Stations & Cycle Pumps.

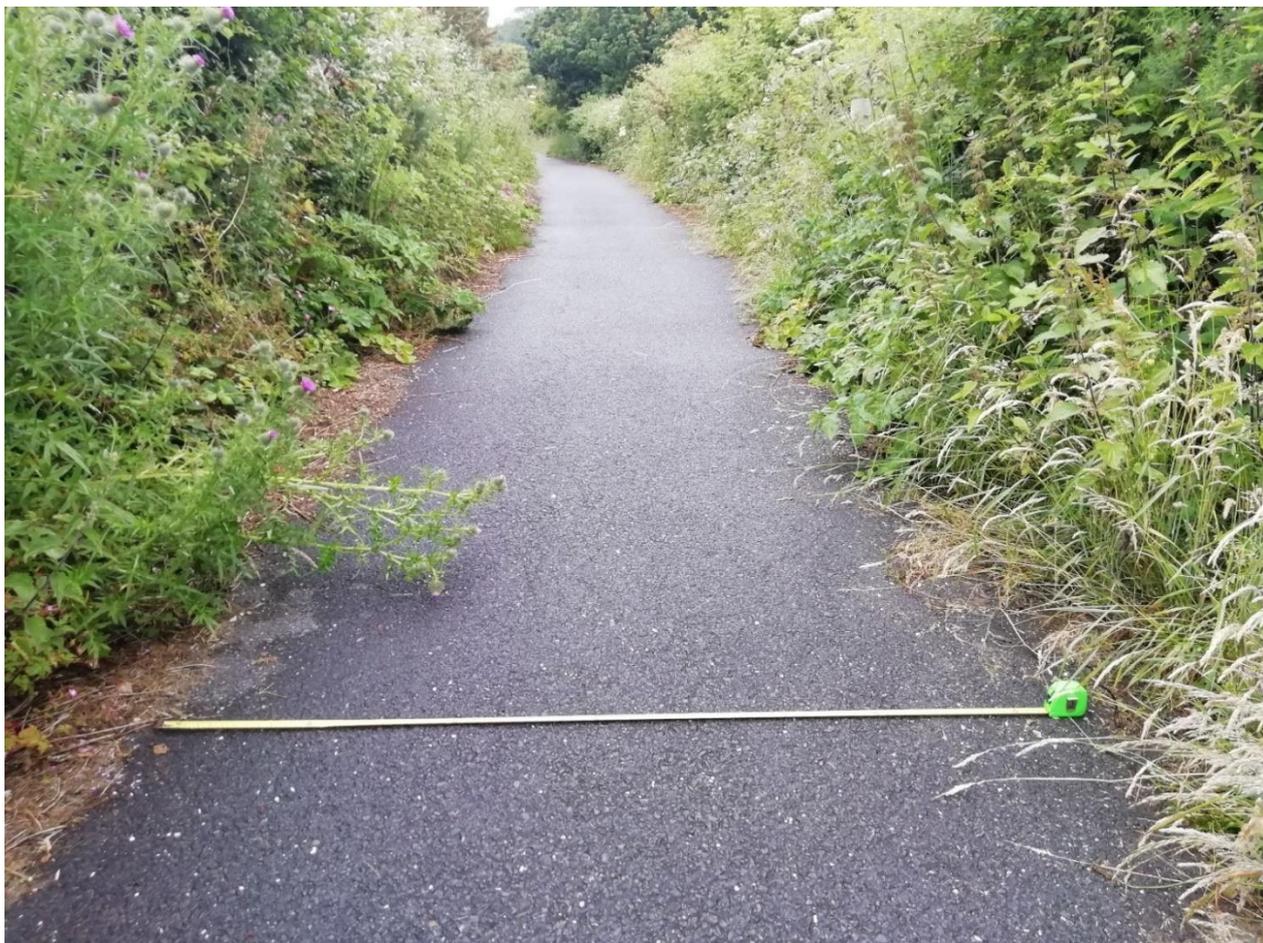
Figure 5: Ystwyth Trail July 2021:

- Figures 5 – 7:** Show the Ystwyth Trail where vegetation creep has reduced path width to less than 2m, though the path was constructed to 3m width.
 - Figures 8 – 9:** Show the Rheidol Trail with overhanging branches and vegetation reducing available path width.

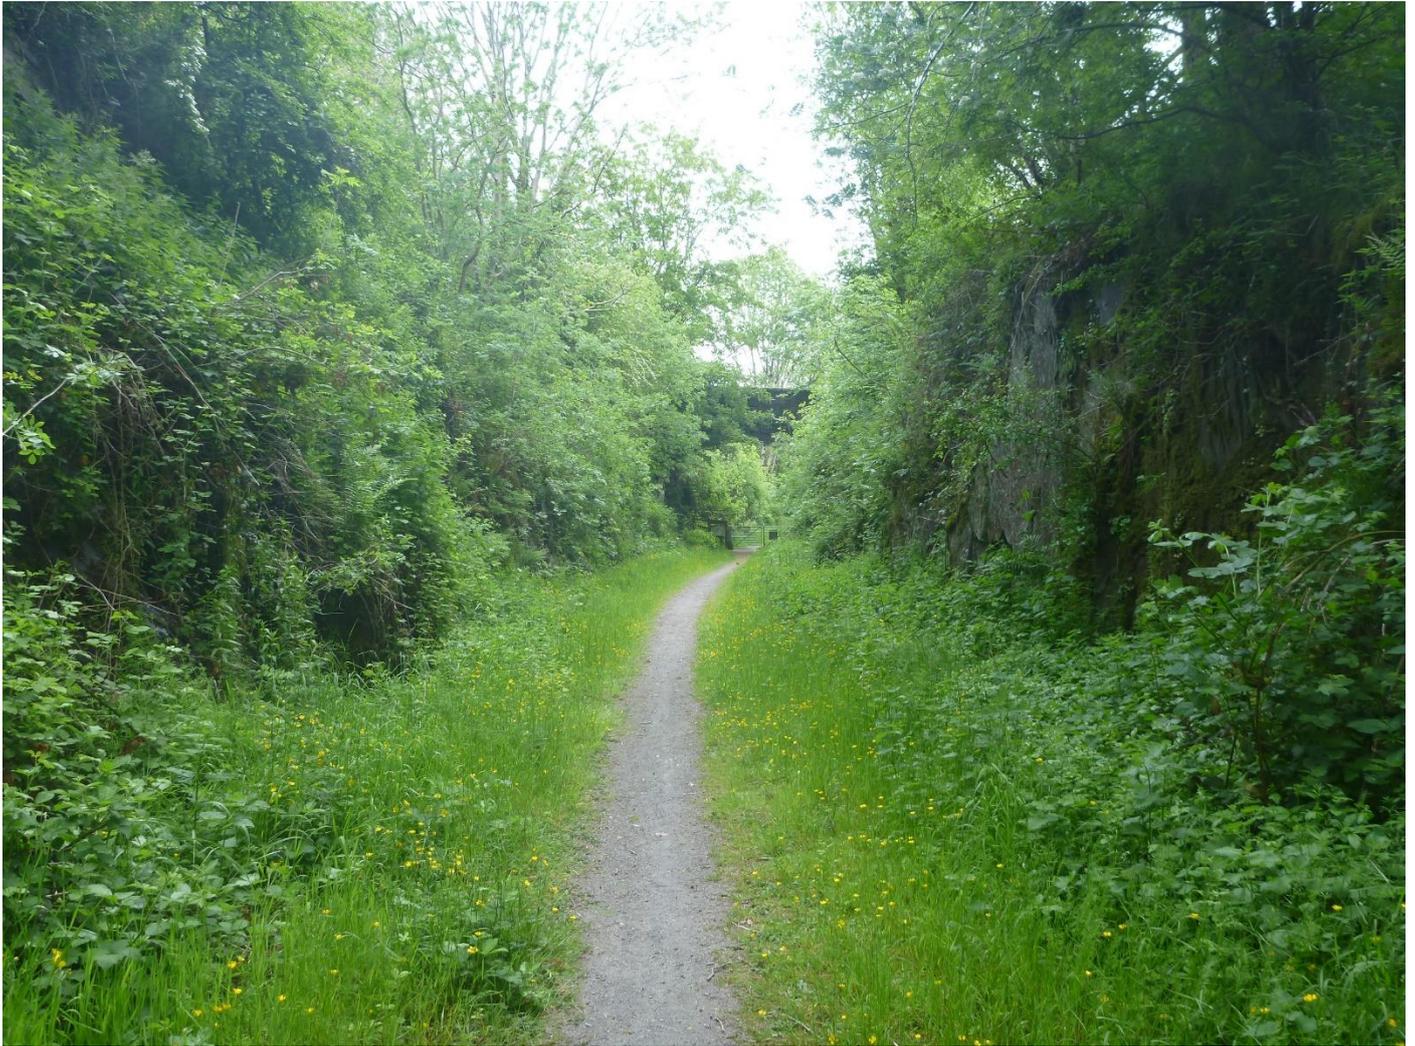
Figure 7: Ystwyth Trail near Tynygraig Jun 2013

This section was originally constructed as a 3 metre wide path provision, yet lack of adequate and regular maintenance has reduced this to single-track, because continual vegetation creep has forced users to the middle of the trail:

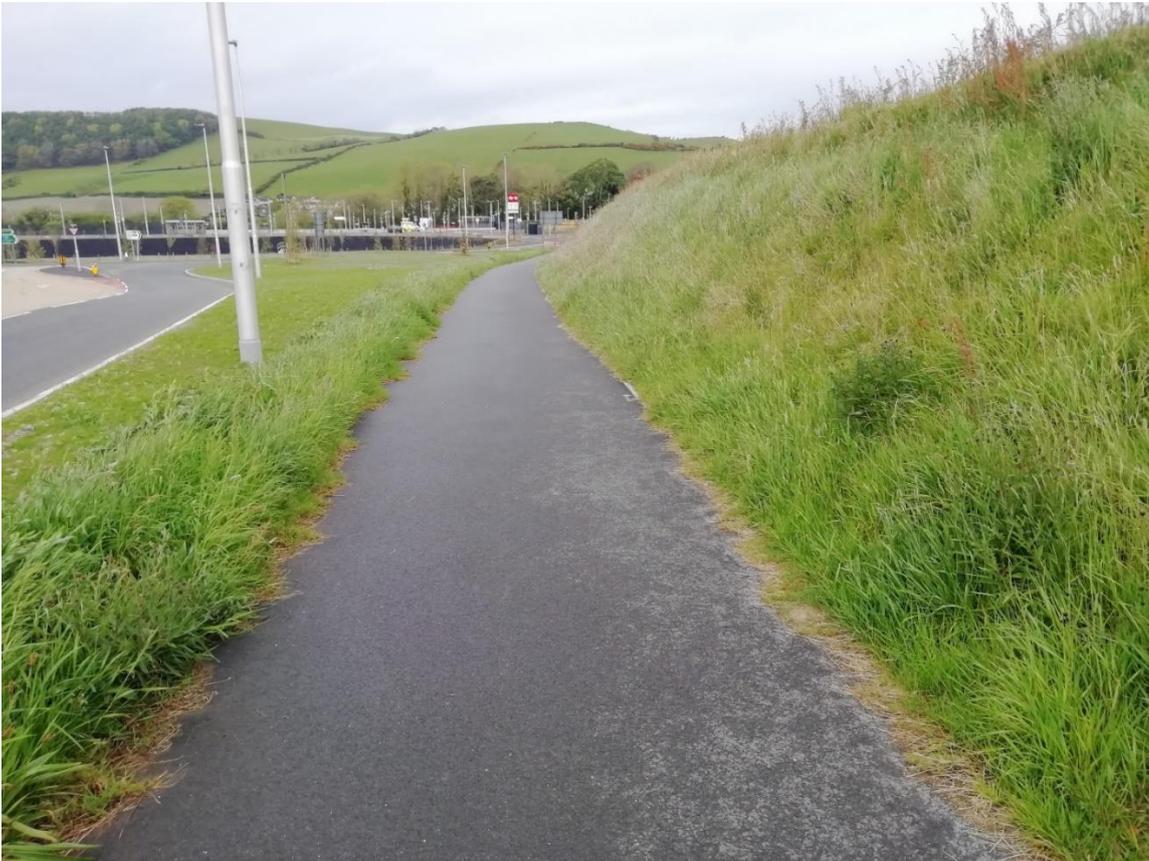
Figure 10: Bow Street to IBERS Shared Use Path

May 2021 - This path was constructed in early 2019 and is already showing signs of vegetation creep over the path edges:

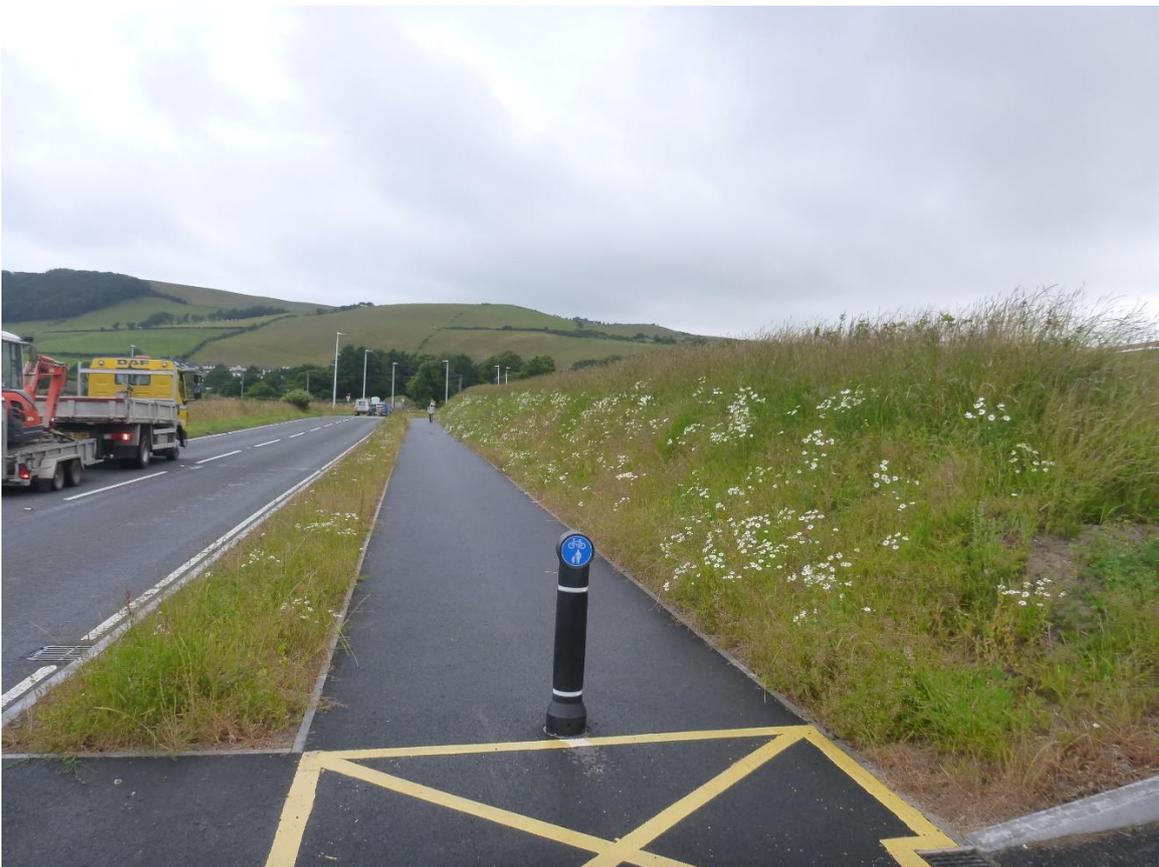
Figure 11: July 2019 – Path edging visible below:

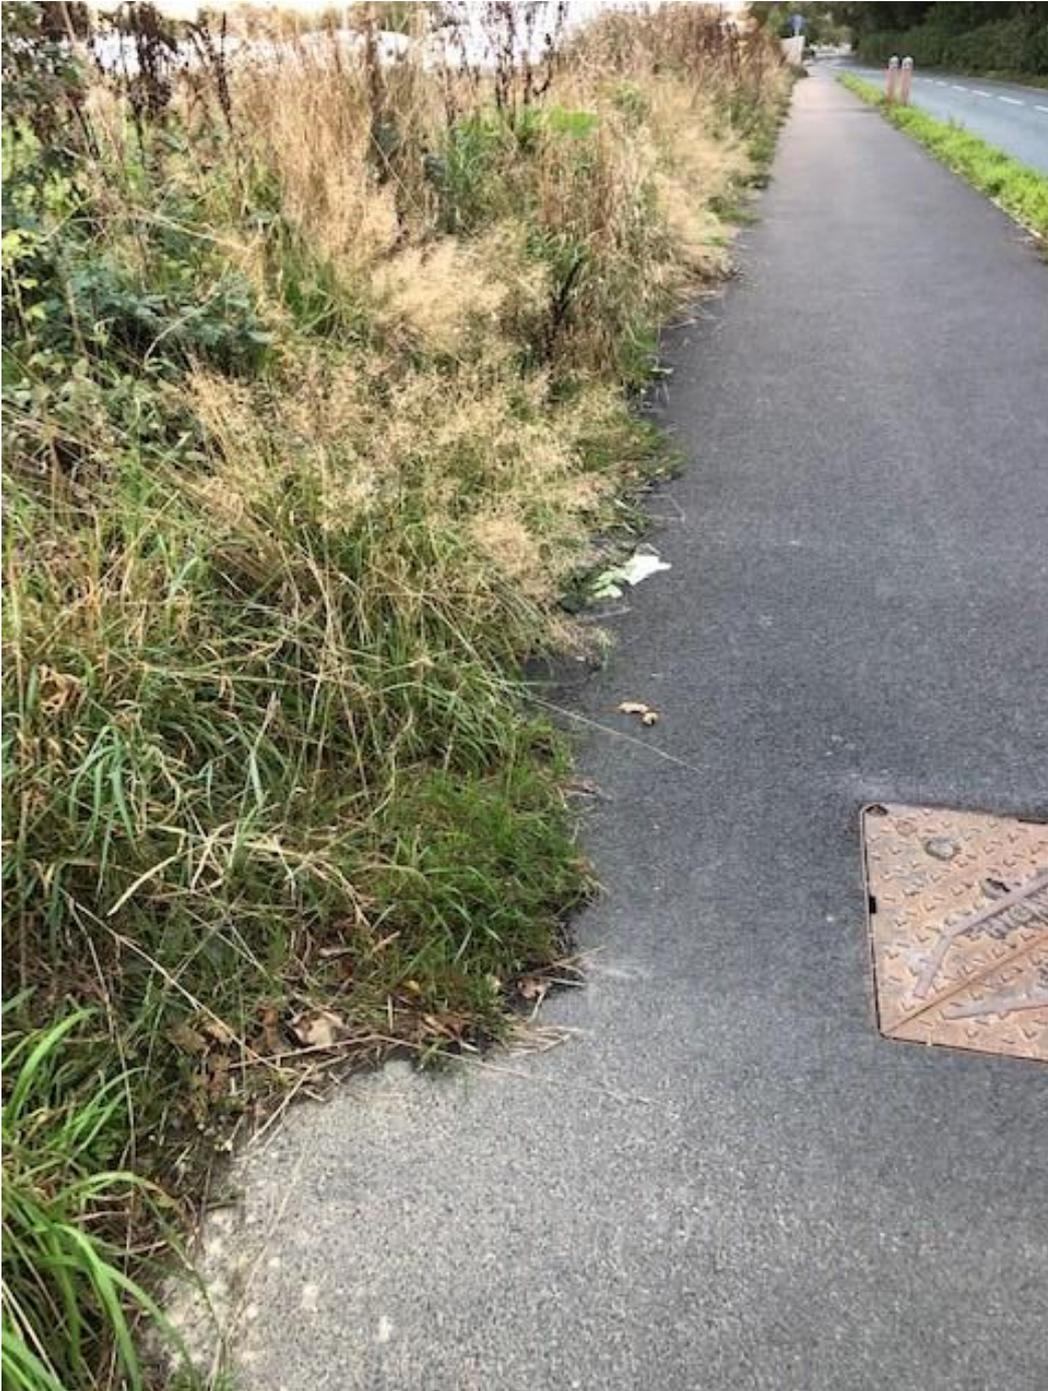
Figure 12 IBERS to Penrhyncoch Shared Use Path

Photo below demonstrates how quickly vegetation creep can occur as this path was recently constructed in 2020.

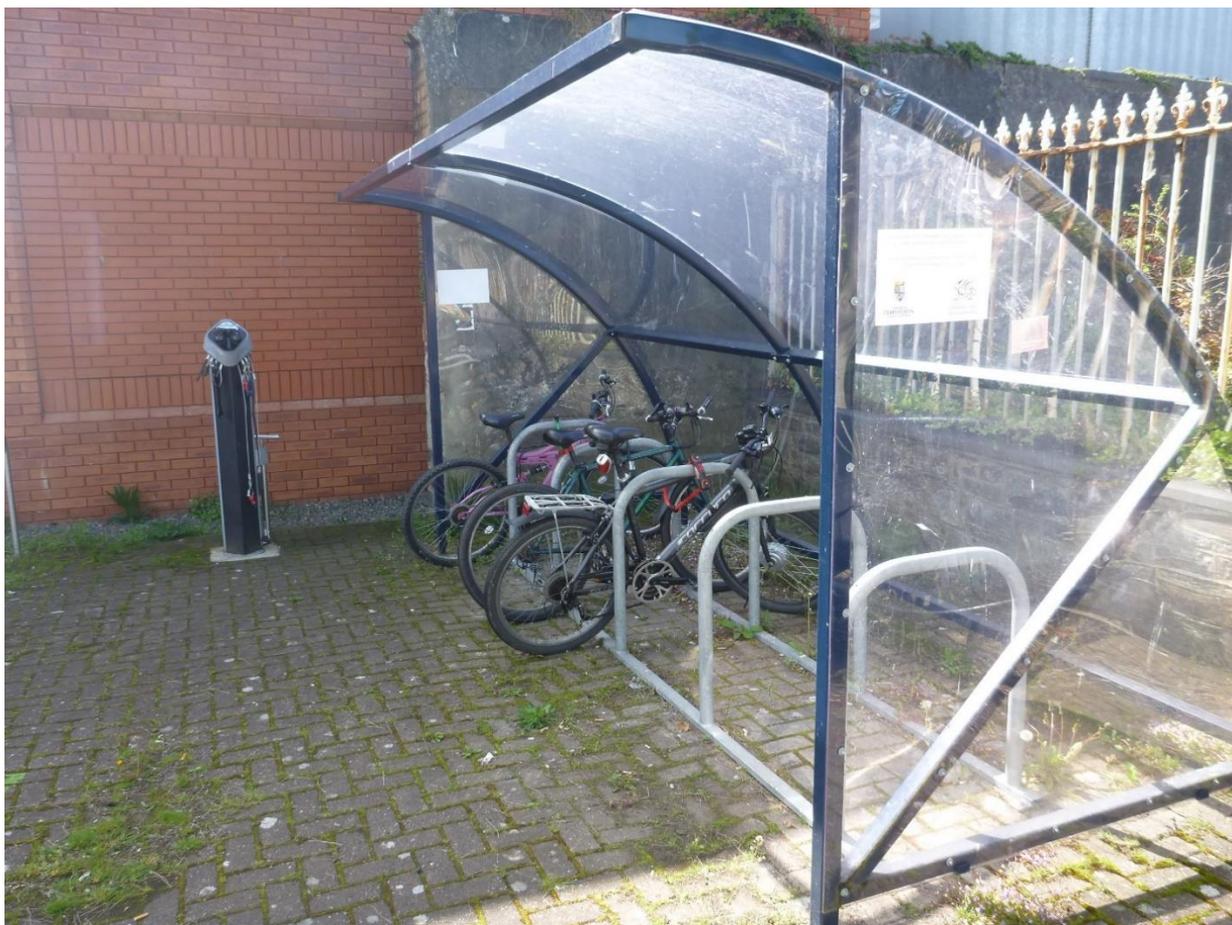
- There is inevitably an additional / increasing path network and associated Active Travel facilities and infrastructure to maintain e.g. cycle shelters, public bike repair stations and cycle pumps etc. (**Figures 13 – 18**).

Figure 13: Cycle Shelter and Public Bike Repair Station and Cycle Pump near Aberystwyth Rail Station – May 2018:

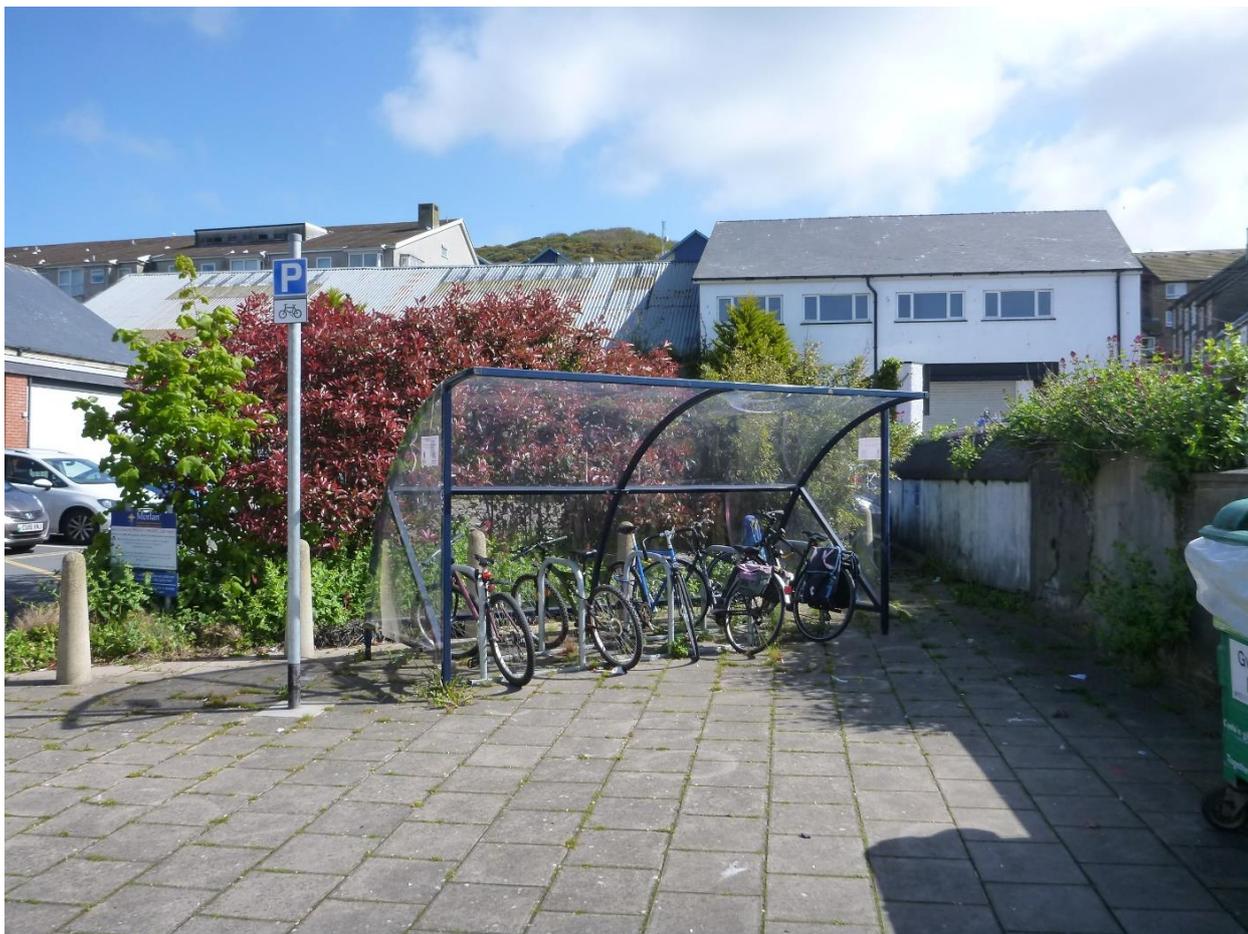
Figure 15: Queen's Road, Aberystwyth Cycle Shelter – May 2018:

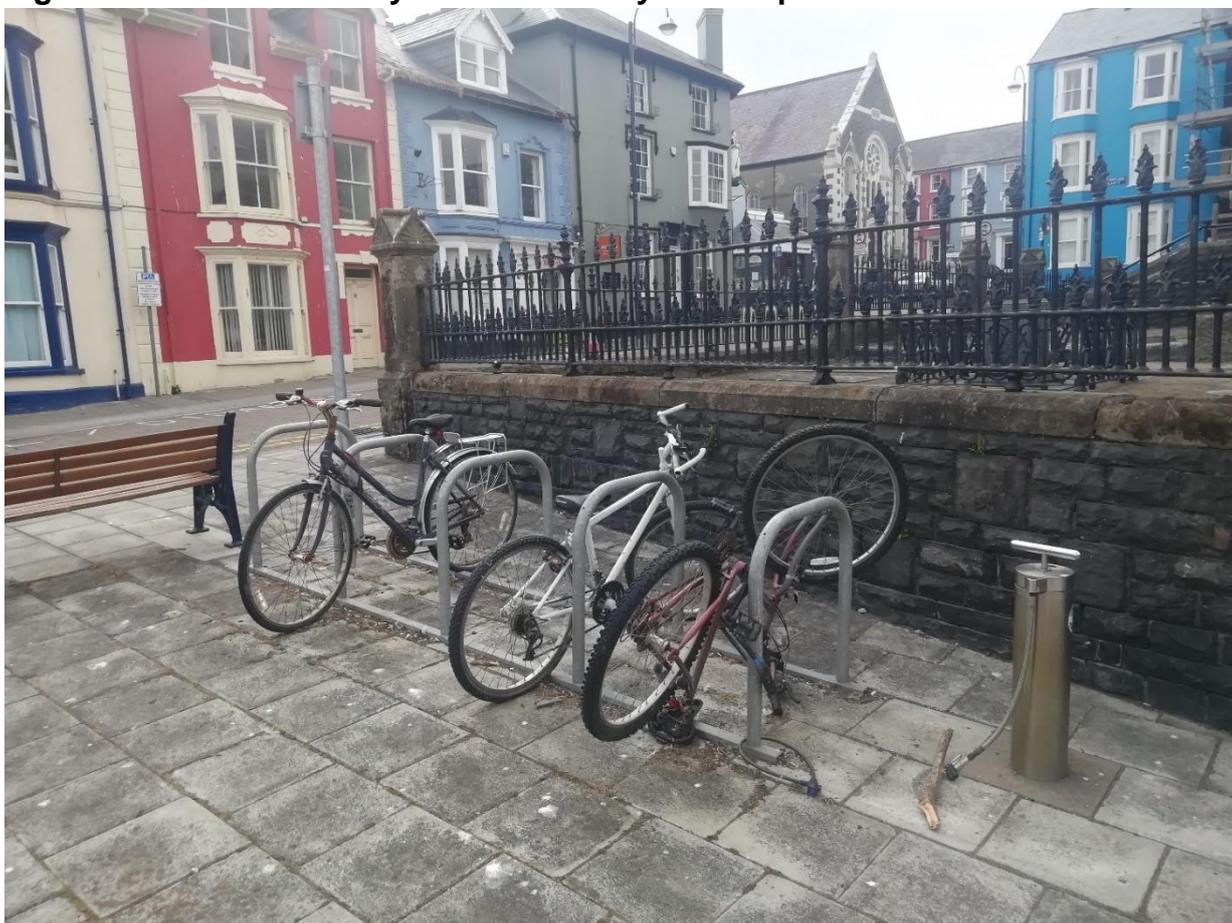
Figure 18: Baker Street Cycle Rack and Cycle Pump:
